**ASBESTOS SURVEY
REPORT FOR**

Commercial Demolition
225 S. Main St.
Three Rivers, MI

SURVEY CONDUCTED

11/26/19

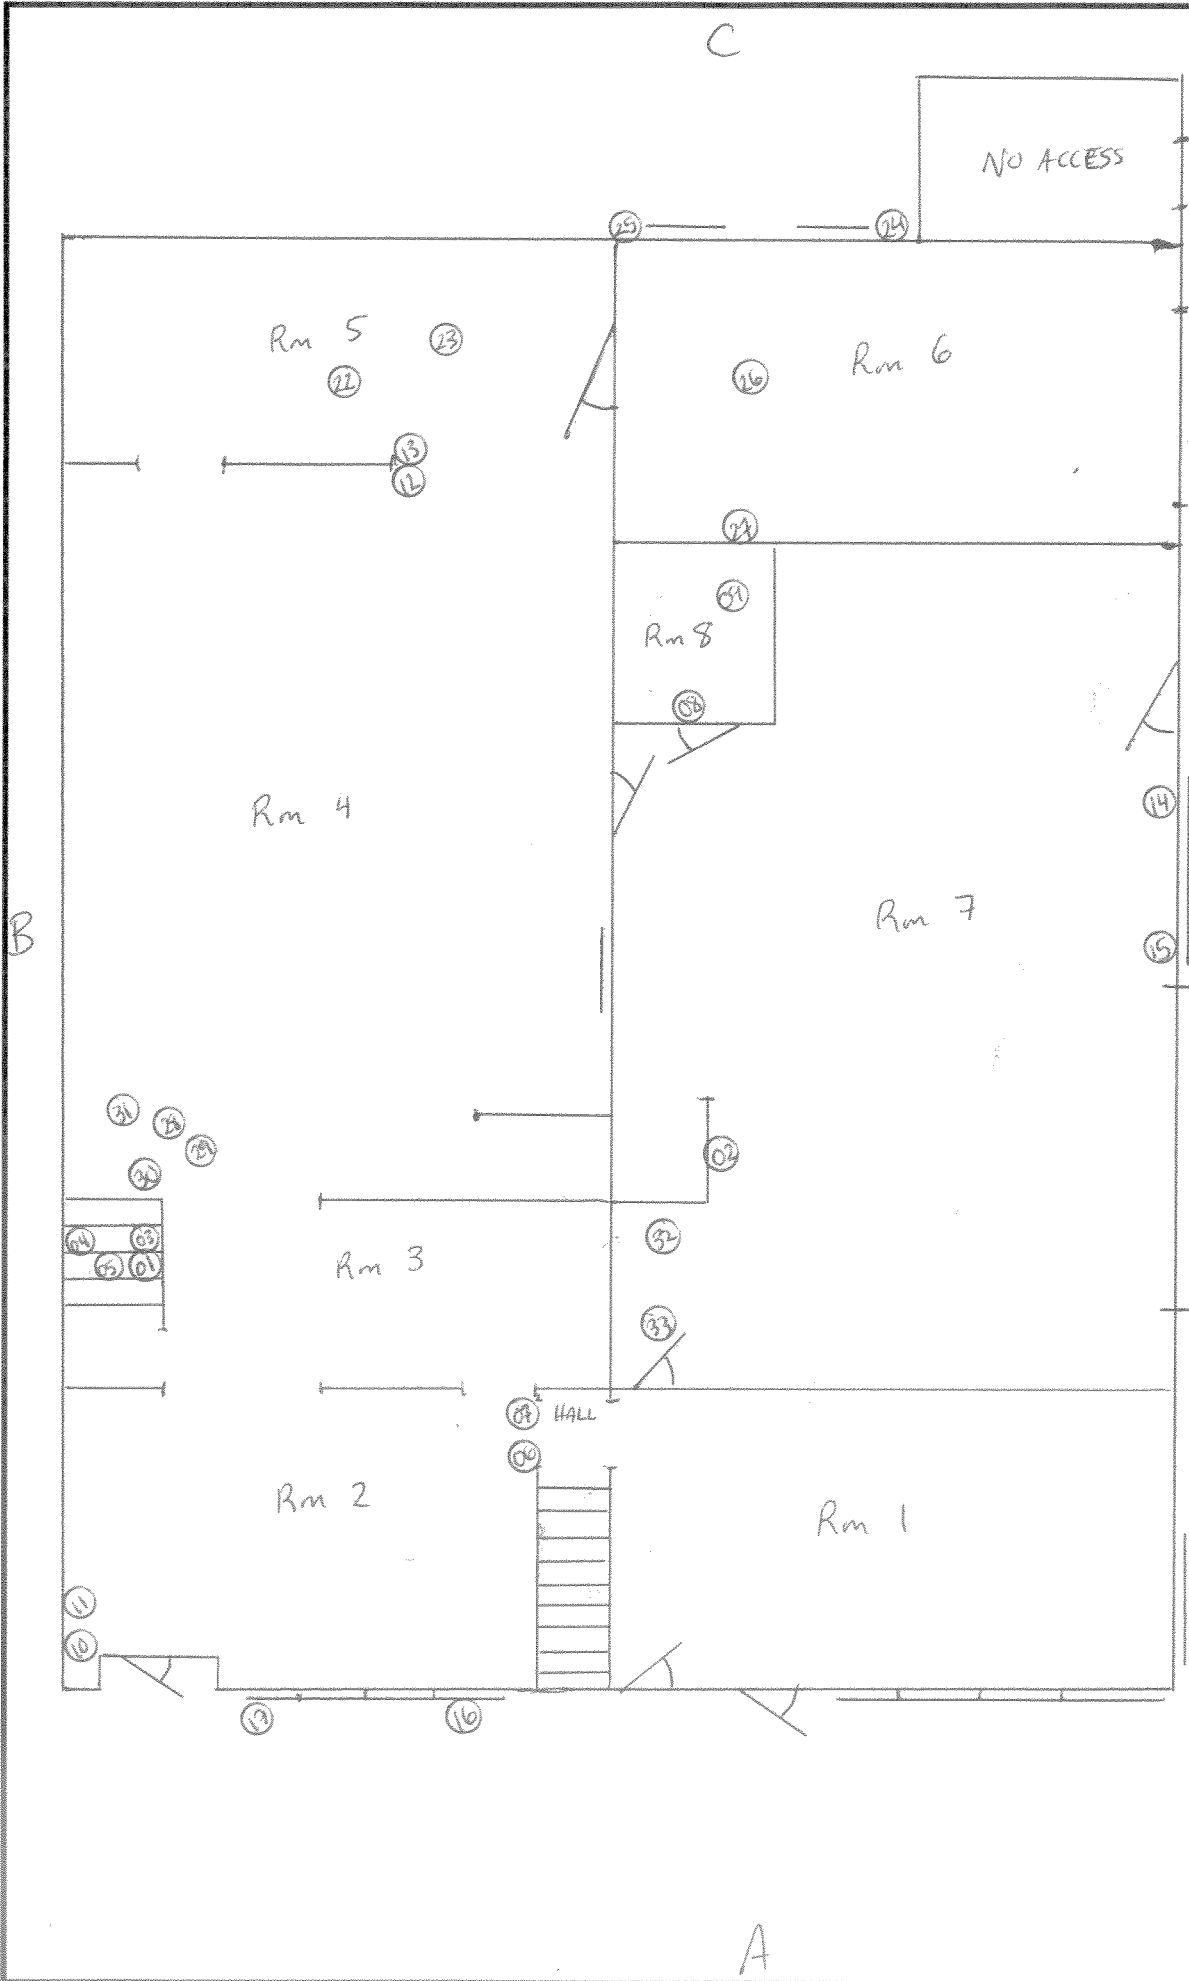
ANALYTICAL TESTING & CONSULTING	
ADDRESS: 225 S. Main St.	1st Level
Three Rivers, MT	
DATE: 11-26-19	LAB #: 4961
DRAWN BY: Tim R.	SCALE: NTS
